Eclipse SAN Routers

Enterprise/ Operating System internetworking
Version 04.05.00
SANvergence Manager 04.06.02

Release Notes P/N 958-000364-450 Rev C

7/28/05

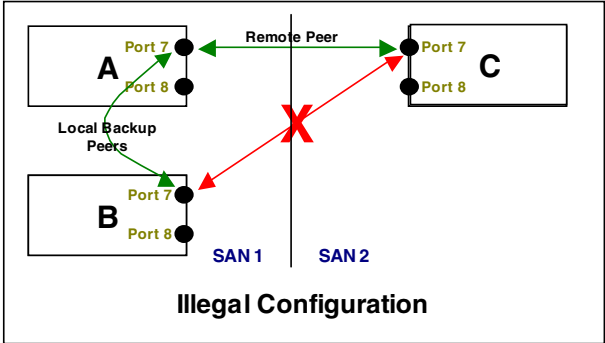
<p>Illegal Configuration</p>

Note	Category
<p>A remote port cannot be used as a remote peer for a local router port if that local router port is configured to be a backup port for another local router port that has already been configured to use the same remote port as a remote peer.</p> <p>For example, in the following figures, there are three 3300 SAN Routers: SW “A”, SW “B,” and SW “C.”</p> <ul style="list-style-type: none"> SW “A” and SW “B” are in the same fabric and have the same SAN ID. SW “C” is in another fabric with a different SAN ID. <p>If SW “B” Port 7 is configured as a backup for SW “A” Port 7, and SW “A” Port 7 is already configured as a remote for SW “C” Port 7, then SW “C” Port 7 cannot be used as a remote for SW “B” Port 7. SW “C” port 8 can be used as a remote for SW “B” ports 7 or 8.</p>

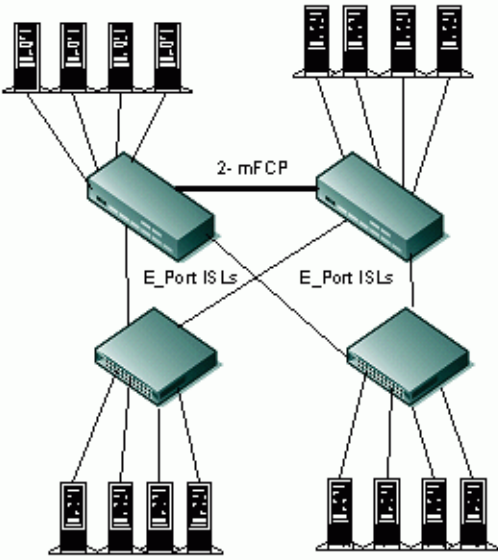
Tracking Number	Description	Product Area	Model
44023	<p>When using the configuration shown below, after resetting the Eclipse 3300 and starting all 16 devices at the same time, frames may be sent to local devices with SID = 0x000000. This may occur on PLOGI and Data frames. If each device is started with a two-second delay between each initialization then all devices should come up and establish connectivity, with some of them possibly having to retry PLOGIs.</p>
